Number	P.1
Section	Electrical and Instruments
Sheet	1 (of 1)
Date	January, 1960

INSTRUMENTS, OVERDRIVE AND AUTOMATIC  
TRANSMISSION INDICATOR LIGHTS

Mark 2 Models

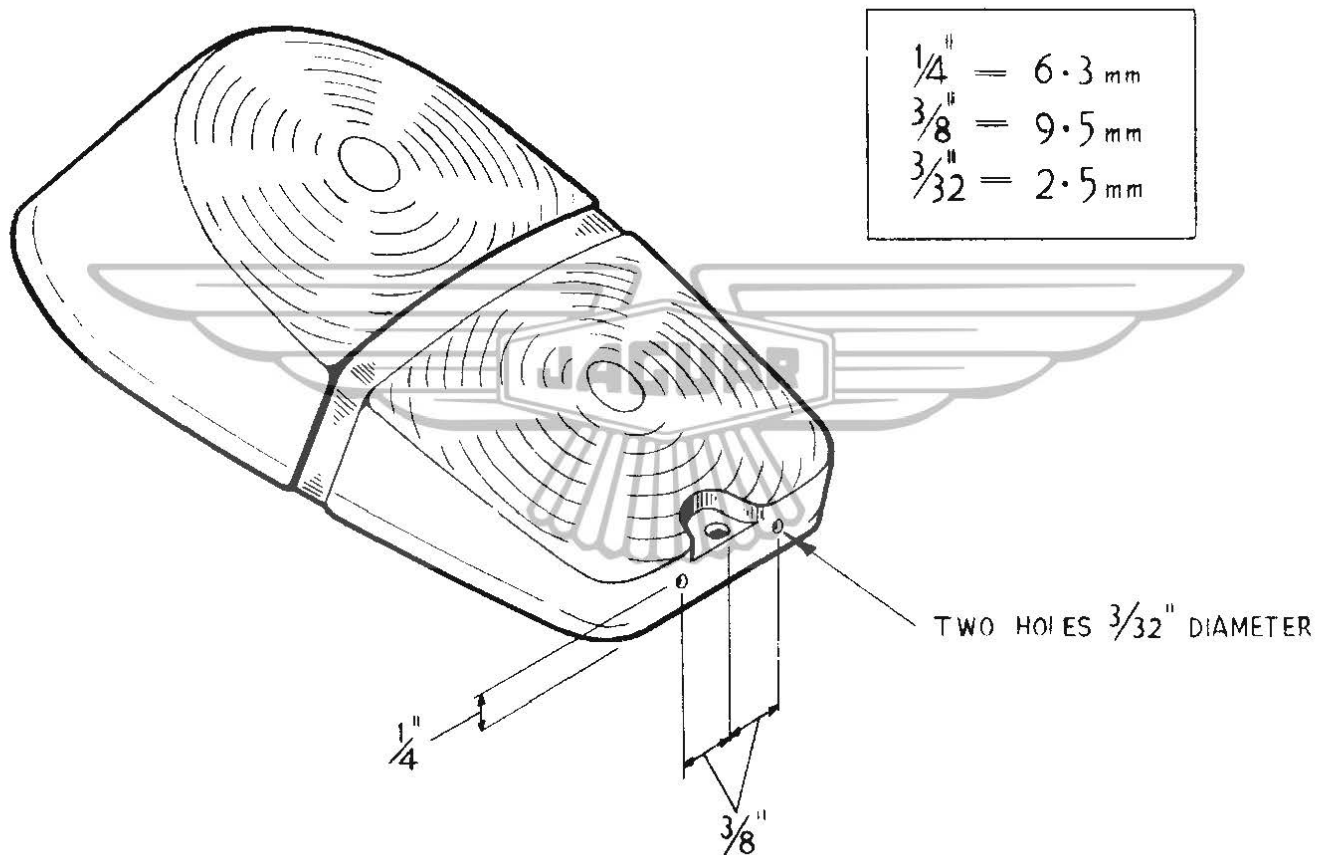
A certain number of 1960 cars with the new type rear lamps (with separate flasher and tail light bulbs) were sent out of the factory without the drain holes in the bottom of the lamp lens.

Cars in stock or cars coming in for servicing should be checked for having two holes drilled in the bottom of the rear lamp lens. If not so drilled, two holes should be made in the bottom of the lens as shown in the sketch overleaf.

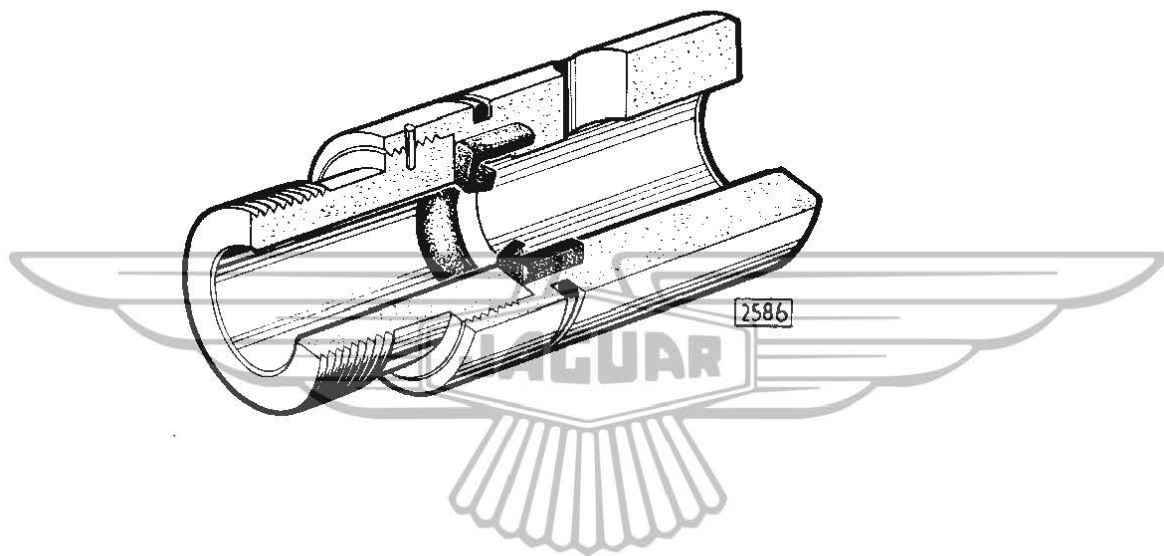
If oil is found to be working past the inner seal it will be necessary to dismantle the driven gear bush as follows:-

Remove the rubber seal from the recess in the bearing. Fit a new seal (Part No. C.8773) so that the open end of the seal through which the spring is visible, is facing the bottom of the recess of the bronze bearing (See illustration overleaf).

Screw the adaptor into the bearing and fit a new retaining pin. If necessary, drill a new 1/16" (1.5 mm) hole not more than 7/32" (5.5 mm) deep in the side of the bearing; fit a mild steel pin, peen over and file flush.

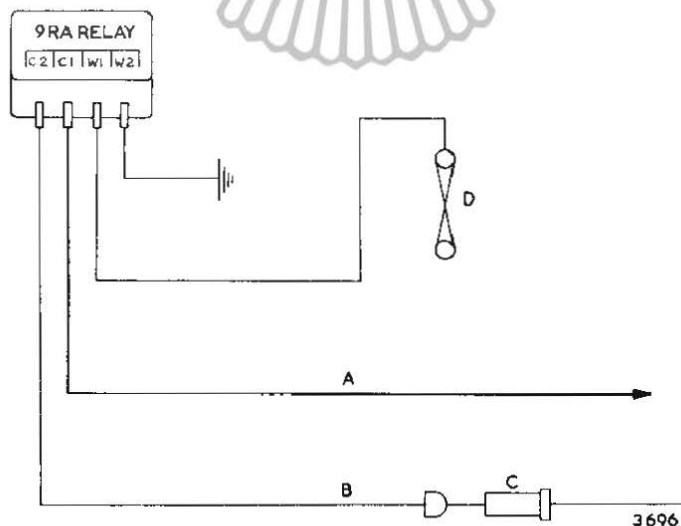
Isolated instances have occurred of ignition switch failure on cars fitted with an Air Conditioning System.

This has been traced to an excessive load being imposed on the two evaporator fan motors when operating under certain adverse conditions conducive to icing up, resulting in an overload on the ignition switch contacts and subsequent breakdown.

To prevent this fault recurring, a Lucas 9 RA Relay (Part No. C.19085) has been introduced into the Air Conditioning Electrical circuit on current production cars, the revised circuit being as illustrated.

If complaints are received of ignition switch failure, it is recommended that the relay is fitted in a convenient position and the circuit modified. The main output terminal (A) should have a 35 amp terminal fitted to connect to the alternator.
